# Manhole Inspection Summary

Manhole # S33MM\_053MH

Insp Date: **11/30/06 9:51 AM**

**Location** Address: **17 21ST ST**

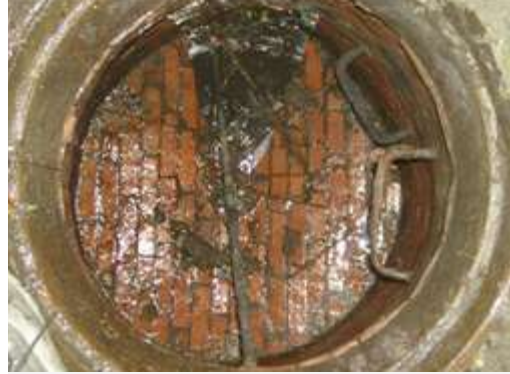
Top View

☒ **Debris** (not Condition related)

**Steps** Count: **2** Missing: **0** ☒ **Corroded**

Corroded steps. Channel debris.

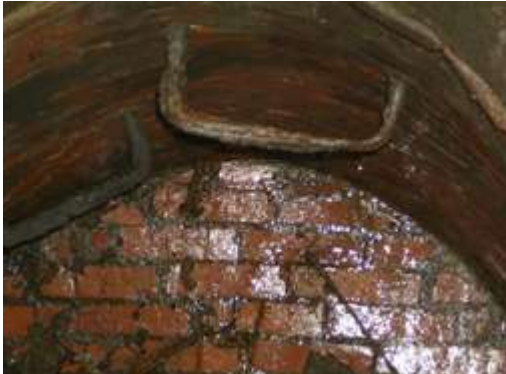
Defect

☒ **Leaks**

Infiltration: ☐ None ☒ **Joint** ☐ Cracks ☐ Mortar ☐ Roots ☒ **Wall**

Infiltration: ☐ None ☐ Joint ☐ Cracks ☐ Mortar ☐ Roots ☒ **Wall**

Frame leaks. Corbel and Barrel infiltration.

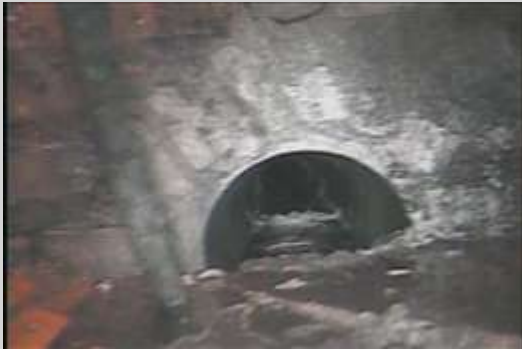
8 in. Circular Gravity Sewer  
Pipe Out @ 12 O'Clock

Deposits: ☐ None ☒ **Mud** ☐ Sludge ☒ **Debris** ☐ Grease

Silt Depth: **3** (in.) Deposits Extent: **Medium**
